Investigations into the Characterization and Source of Corrosion on Anodized Aluminum Alloy Wrist Disconnects of Spacesuit Gloves at the National Air and Space Museum

Lisa Young¹, Christina L. Simms¹⁺² and Aaron Shugar²
 1. National Air and Space Museum, Smithsonian, 2. Art Conservation Department, Buffalo State

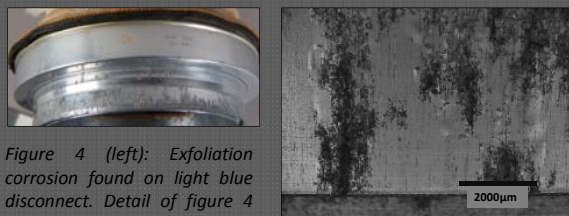
Figure 4 (left): Exfoliation corrosion found on light blue wrist disconnect. Detail of figure 4 (right).

The corrosion (see Figures 3 to 6) is more prevalent on the interior of the disconnects and at the interface where the soft materials are joined to the metal disconnect. Hydrochloric acid gas caused by deteriorating rubber components and human sweat are the likely sources of the chlorides. FTIR identified acetates on all samples indicating another form of corrosion, probably from the nickel acetate used in the anodizing process.

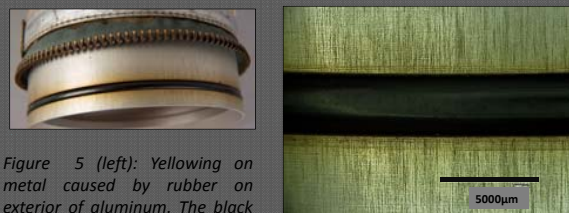
Figure 5 (left): Yellowing on metal caused by rubber on exterior of aluminum. The black line is a rubber o-ring. Detail of figure 5 (right).

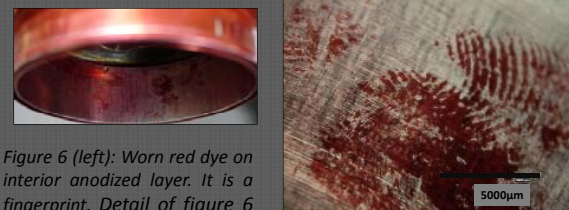
Figure 6 (left): Worn red dye on interior anodized layer. It is a fingerprint. Detail of figure 6 (right).

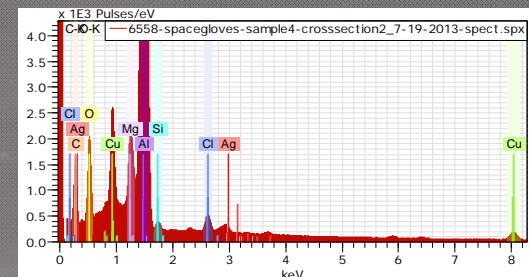
Figure 7: SEM spectrum of an Apollo period glove seen in Figs. 8-9

Samples were too amorphous for conclusive results with XRD. XRF and SEM results confirm the presence of chlorides (see Figures 7 to 9), expected metal constituents, and confirmed the use of two different alloys.

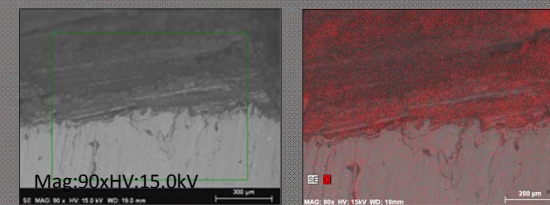
A higher copper content in 2024 Al may have caused these disconnects to be more susceptible to corrosion than 7075 Al. An anti-oxidant added to the rubber after 1971 (Apollo 14) also inhibited the breakdown of the rubber and therefore less off-gassing of the HCl occurred. The disconnects on these gloves were found to be more stable.

Figure 8 (left) is SEM image showing a cross-section of an Apollo period disconnect, the dark areas are corrosion. The red color Figure 9 (right) demonstrates the concentration of Cl, in the areas of corrosion.
