## When Modern Materials Fail: Rehabilitation of a Taxidermy Orangutan

Fran Ritchie, Graduate Student, Buffalo State College; Jonathan Thornton, Objects Professor, Buffalo State College; Dr. Aaron Shugar, Conservation Scientist, Buffalo State College

Introduction: This juvenile female orangutan died at the Buffalo Zoo in 1966 and was mounted by an amateur taxidermist. The specimen was given to the Buffalo Museum of Science in Buffalo, NY, where it was on display until 2002. Damage occurred during de-installation due to the failure of non-traditional materials added to the mount. The specimen was conserved in the Spring of 2012 at Buffalo State College.

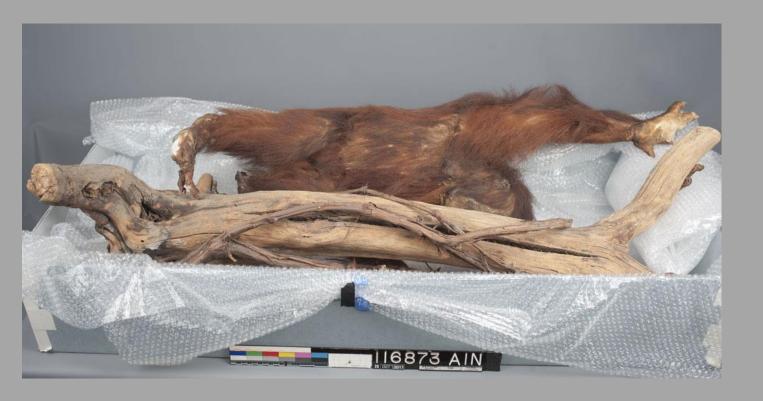
**Investigation:** The original display mounting method failed causing extensive damage to the joining features. The specimen required removal; the materials and construction required investigation prior to treatment.

Left: Specimen on original driftwood display mount; Right: Proper left hand torn and pulling from mount.

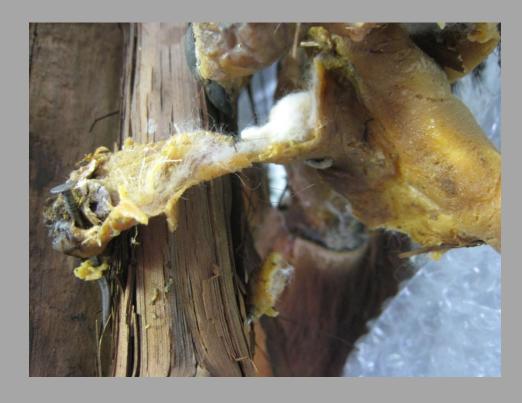
Damage and repair: The hands and feet were ripped and torn with several fingers broken or detached due to poor mounting.

Response: The specimen was removed from the display mount by prying out nails and collecting broken finger fragments. Running ATR-FTIR on skin samples confirmed that the taxidermist replaced the palm skin and pads of feet with latex rubber. X-radiography revealed the internal support.

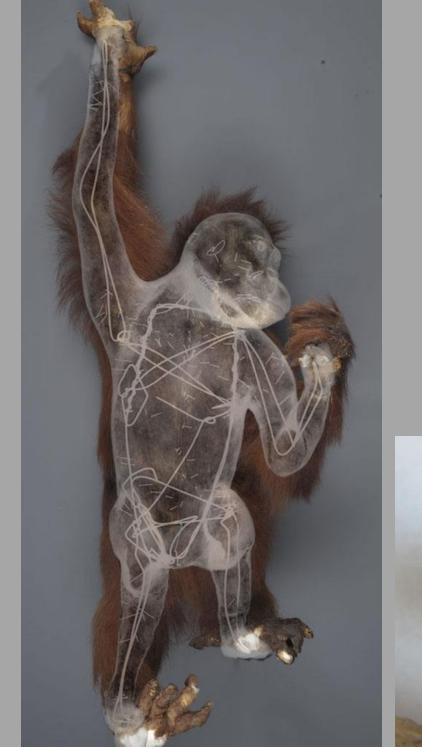
Above: X-radiograph superimposed on normal illumination photograph.

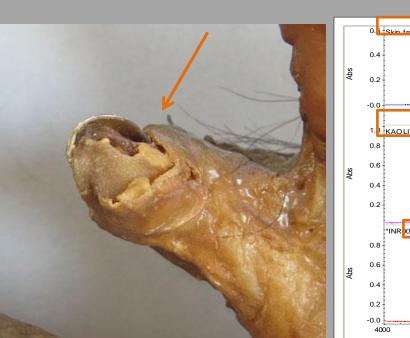
Above left: Rubber pulling away from original skin Above right: ATR-FTIR spectra comparing specimen sample, natural rubber, kaolin.

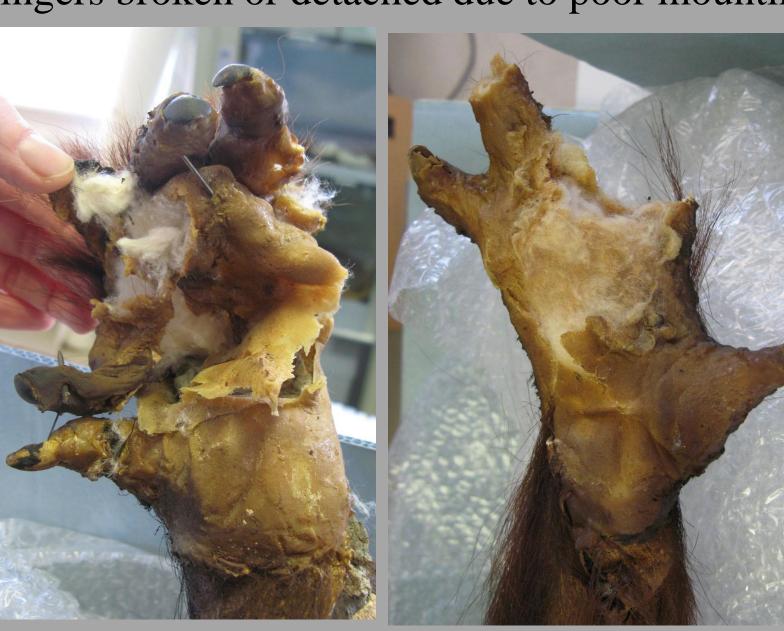
Left: Proper left hand Right: Proper right hand (detached fingers recovered but not pictured).

rubber, and spun polyester flocked with BEVA on the thicker leather pieces (tops of hands and feet).

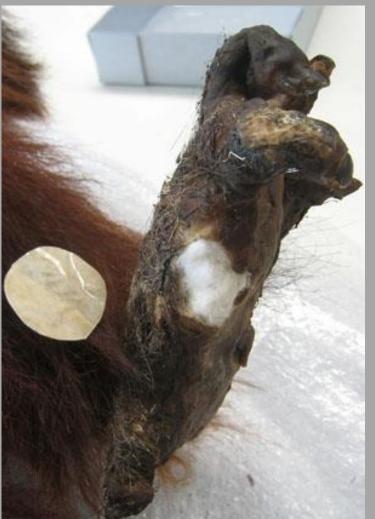
Left: Circular toned fill tissue infused with BEVA film beside hole in proper left foot.

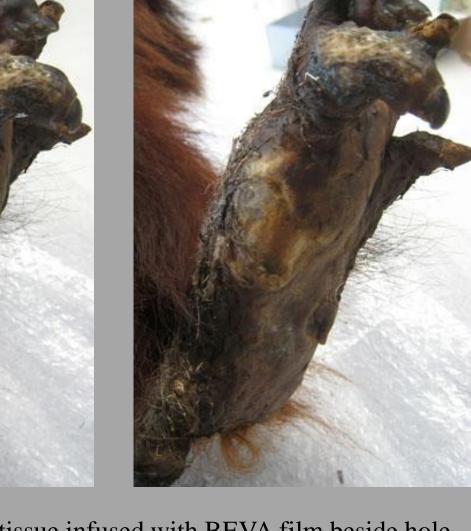
Right: Toned tissue applied to exposed BEVA where original rubber no longer aligned and in-painted.

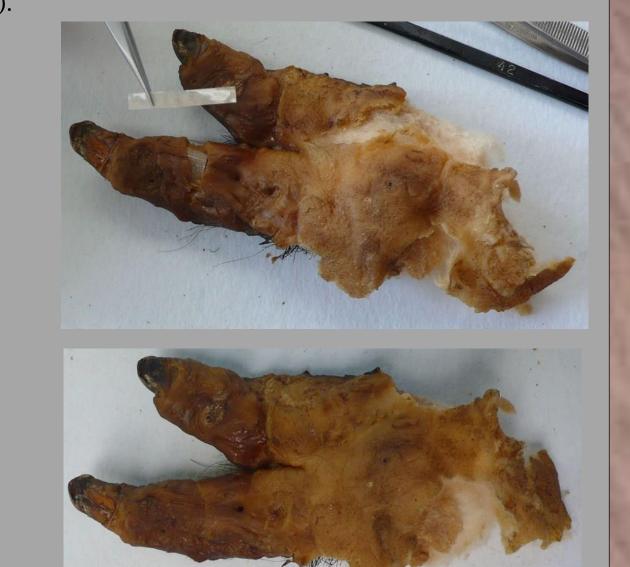
Above: Lining the interior of splits with toned tissue infused with BEVA.
Below: After setting the linings using heat.

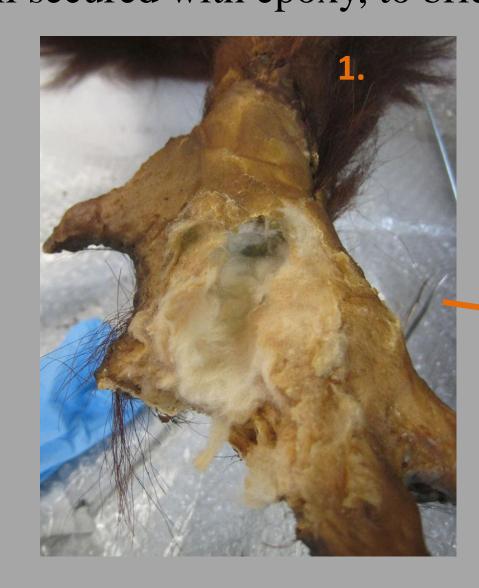
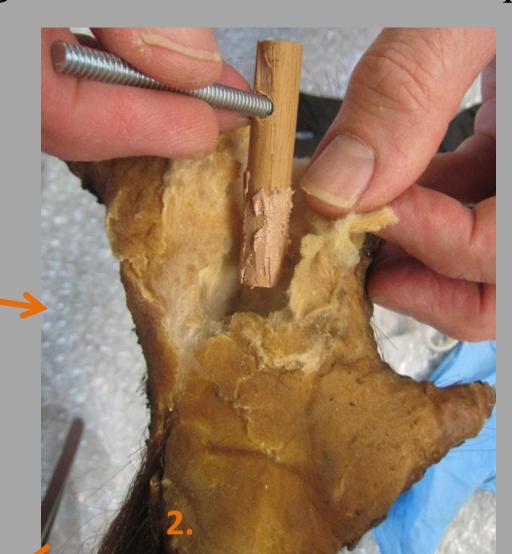
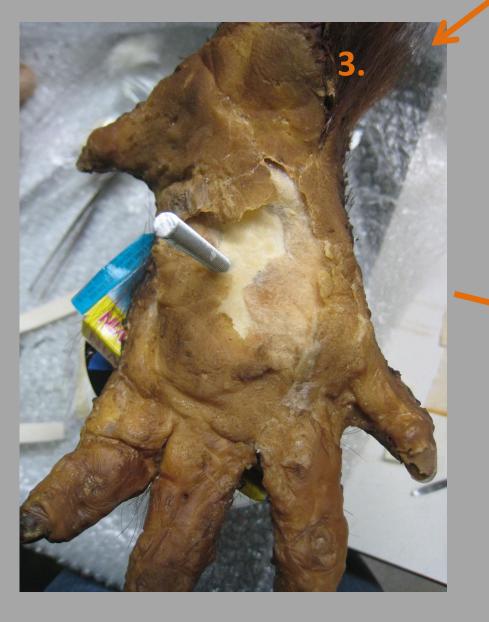
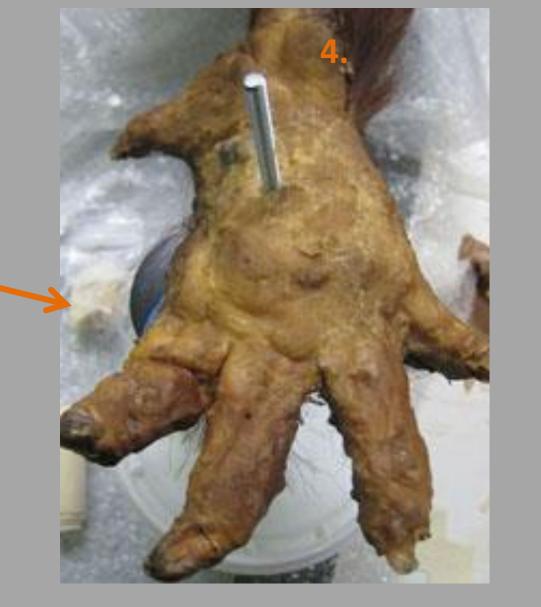
Repairing Mount: The specimen needed a new display mount that could support it without further damaging the deteriorating latex rubber.

**Response:** Threaded metal rods were inserted into the hands and proper right foot, all secured with epoxy, to bridge the internal and external supports.

1. The batting was removed from the proper right hand and a hole drilled into the plaster. 2. An epoxy-coated wooden peg with threaded metal rod inserted into drilled hole. 3. Palm reconstructed/reinforced with lightweight spackle. 4. Fingers reattached.

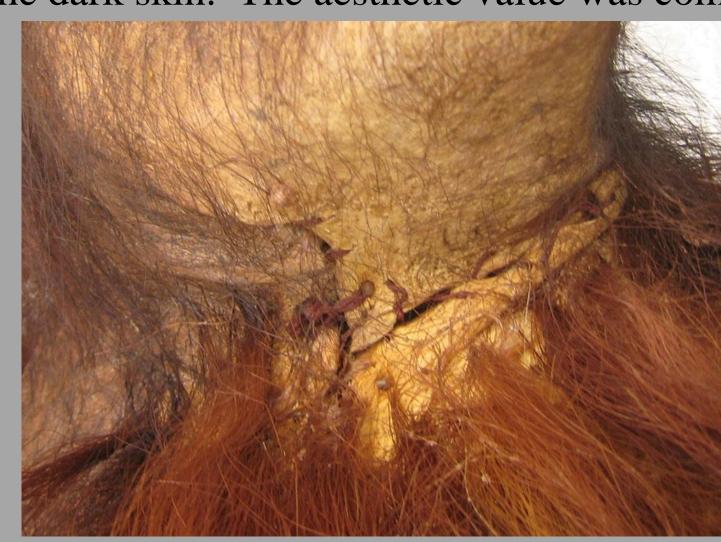
Seam and Loss Repair: The amateur taxidermist mounted the orangutan with misaligned hide and wide, obvious seams.

There were areas of skin loss throughout, present as lighter areas in the dark skin. The aesthetic value was compromised.

Before Treatment under the chin seam.

**Response:** Toned Japanese tissue was applied using BEVA film or wheat starch paste throughout the specimen, as well as in-painting, for visual compensations.

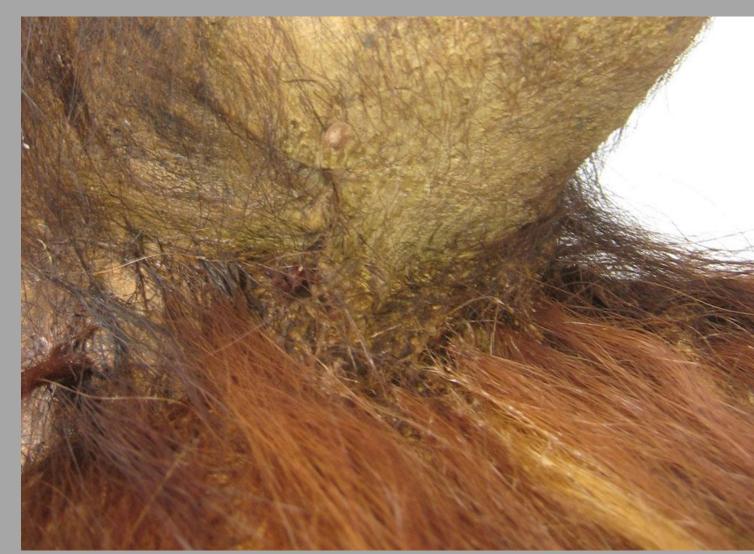
Corresponding After Treatment from toned fills and in-painting
