Investigations into the Characterization and Source of Corrosion on Anodized Aluminum Alloy Wrist Disconnects of Spacesuit Gloves at the National Air and Space Museum

Lisa Young¹, Christina L. Simms¹⁺² and Aaron Shugar²
 1. National Air and Space Museum, Smithsonian, 2. Art Conservation Department, Buffalo State

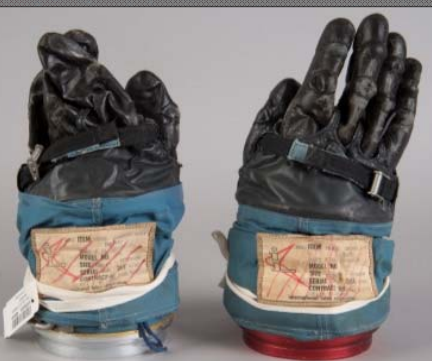
Figure 1: Blue (left) and red (right) aluminum wrist disconnects are at base of gloves. Proto-type Apollo gloves by International Latex Company (ILC), 1966.

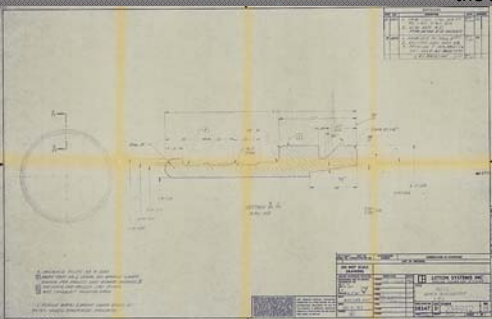
Figure 2: Blueprint demonstrating a cross-section of the wrist disconnect by Litton Systems, 1969. All samples in this study were made by Air-Lock Incorporated.
