## When Modern Materials Fail: Rehabilitation of a Taxidermy Orangutan

Fran Ritchie, Graduate Student, Buffalo State College; Jonathan Thornton, Objects Professor, Buffalo State College; Dr. Aaron Shugar, Conservation Scientist, Buffalo State College

Introduction: This juvenile female orangutan died at the Buffalo Zoo in 1966 and was mounted by an amateur taxidermist. The specimen was given to the Buffalo Museum of Science in Buffalo, NY, where it was on display until 2002. Damage occurred during de-installation due to the failure of non-traditional materials added to the mount. The specimen was conserved in the Spring of 2012 at Buffalo State College.

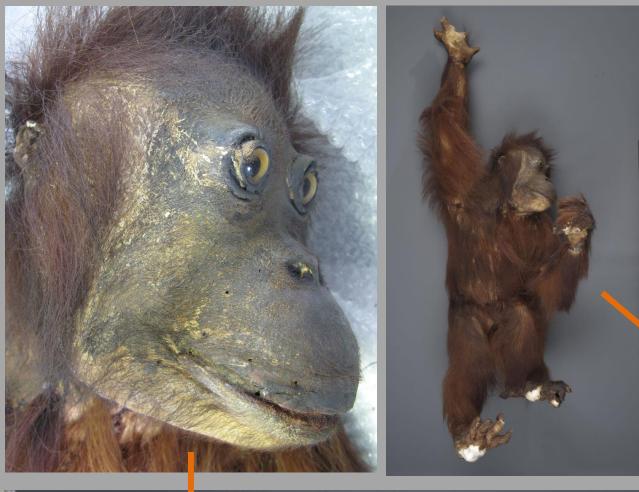
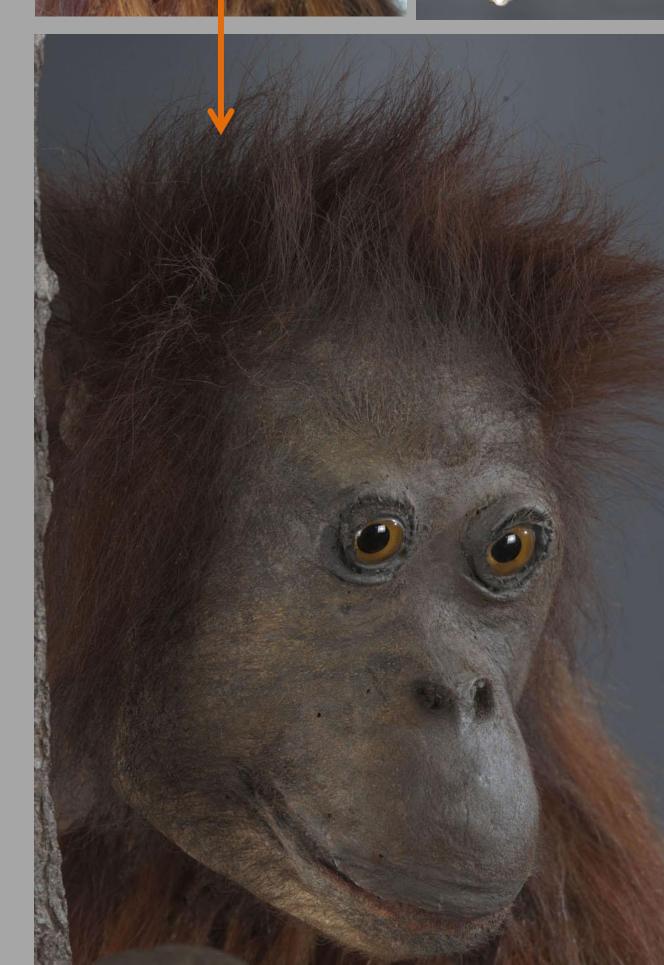
## **Before/After Treatment:**

Seam and Loss Repair: The amateur taxidermist mounted the orangutan with misaligned hide and wide, obvious seams.

There were areas of skin loss throughout, present as lighter areas in the dark skin. The aesthetic value was compromised.

**Response:** Toned Japanese tissue was applied using BEVA film or wheat starch paste throughout the specimen, as well as in-painting, for visual compensations.
